Non-Destructive Evaluation Of Corrosion On Insulated Pipe Using Tangential Radiographic Technique

Alexander Boateng, Dr. K.A. Danso, Dr. C.P.K. Dagadu

Abstract: Tangential Radiographic Technique (TRT) principle was explored for evaluating deposits and corrosion attacks across the inner and outer walls of an insulated steel pipe using Iridium-192. The research was performed on a designed test piece to simulate corrosion attacks and deposits on industrial pipes. Pitting corrosion measurements based on TRT were more sophisticated, and therefore magnification factor and correction were used to establish the estimated pit depth on the film. From the relationship curve drawn between the radiographic film density and the thickness of the pipe, the attenuation coefficient of the insulating material was negligible compared to the concrete deposit. The TRT method overestimated the degree of penetrated corrosion attack in the tangential position in the neighbourhood of 9% and was within an accuracy of ± 0.37 mm. This tolerance limit is 5% less than the wall thickness of the pipe. From the results obtained, effective corrosion monitoring of insulated pipes can reliably be executed by the TRT

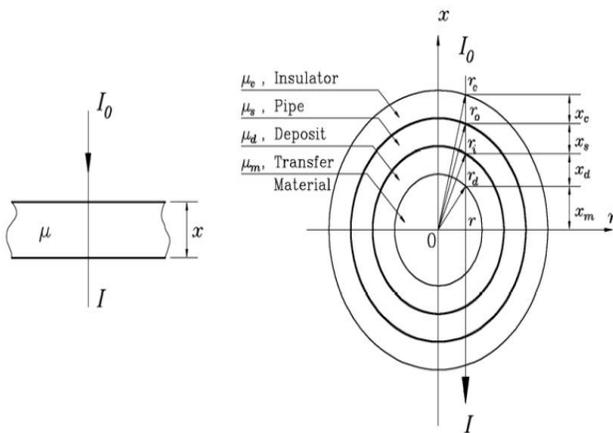
Figure1. Attenuation coefficients for different layers in a typical pipe with deposit on the internal diameter and insulation on the outer diameter [6].

Where I_0 is the intensity of the incident radiation, I is the intensity of the transmitted radiation, μ_c, μ_s, μ_d and μ_m are the attenuation coefficient of concrete, steel, deposit and transported material respectively. X_c, X_s, X_d and X_m represents thickness of

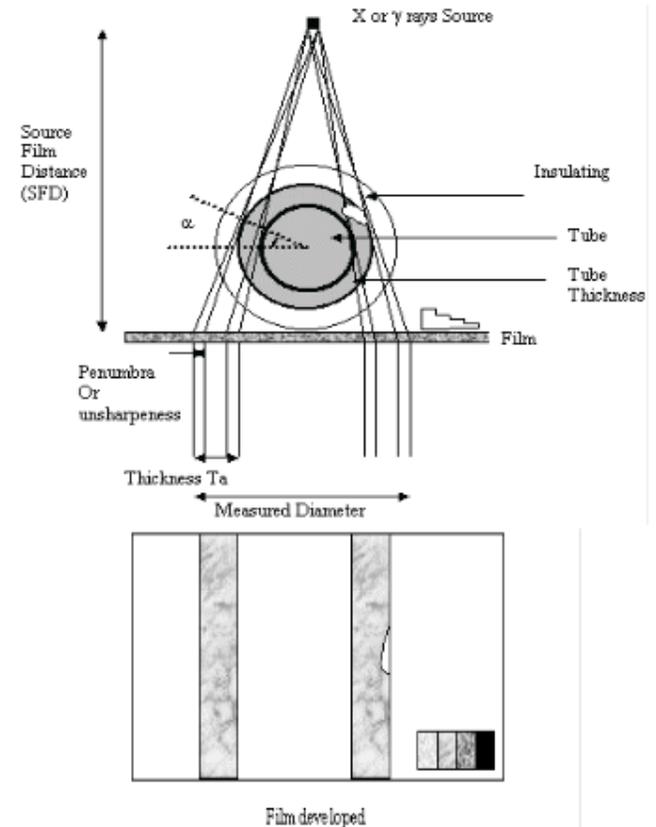
Figure 2: Tangential radiography set-up [2].

concrete, steel, deposit and transported material respectively. The exposure angle (α) is a function of the Source Film Distance (SFD) and the Outer Diameter (OD). By changing the SFD, the tube position can be rearranged to project suspected defects on to the film with optimum resolution and contrast parameters. The relationship that determines the radiation exposure angle (α) is as shown in figure 2.

$$\alpha = \frac{\cos^{-1}(0.5 OD)}{SFD - 0.5 OD} \tag{7}$$

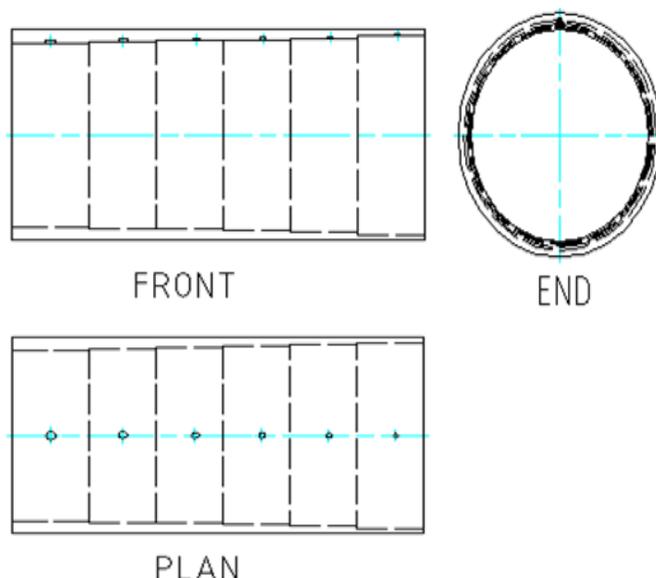
Figure3. Orthographic views of the interiorly machined pipe.

- Step pipes with holes (pits) inside and outside - one pipe specimen with machined steps inside and other pipe specimen with machined steps outside. "t" is the pipe wall thickness before introducing steps or any discontinuity.
- Each step chosen to range from 0 to 0.7 t in steps of 10% wall thickness; precision in wall thickness shall be ± 0.1 mm.
- Hole diameter equal to remaining wall thickness, minimum of 3.00 mm.
- Hole depths ranging from 0.50 mm to 3.00 mm spaced at different circumferential positions; holes were to be flat bottom.
- Where steps were located on the inside surface of the pipe, material was to be removed by grinding or machining to a depth of 15% of maximum wall thickness of the pipe, forming a flat surface. Length covering all the steps. Precision was to be ± 1% [6].

INTERIOR MACHINED PIPE			LENGTH OF PIPE = 302.00 m			
Step	Step Block Thickness (mm)	Pits (Drill) Diameter (mm)	Pits Depth (mm)	Outer Diameter (mm)	Inner Diameter (mm)	Step Bl Leng (mm)
Step 1	4.50	3.00	0.50	163.00	154.00	49.0
Step 2	6.40	3.20	0.80	163.00	150.20	49.0
Step 3	7.20	4.00	1.20	163.00	148.00	49.0
Step 4	8.50	4.50	1.60	163.00	146.00	49.0
Step 5	9.40	5.00	2.00	163.00	144.20	49.0
Step 6	10.50	6.00	2.50	163.00	142.00	57.0

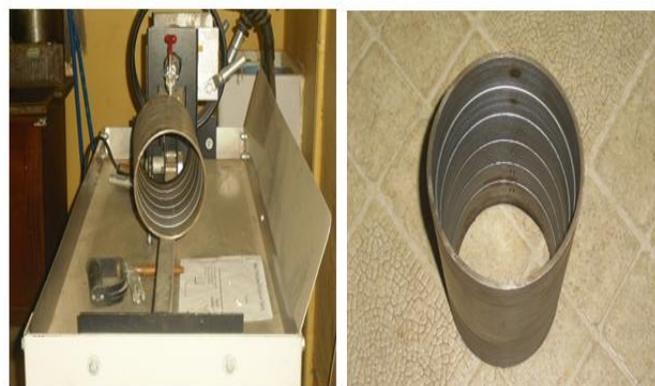
Figure4. Interiorly machined pipe (test pipes).

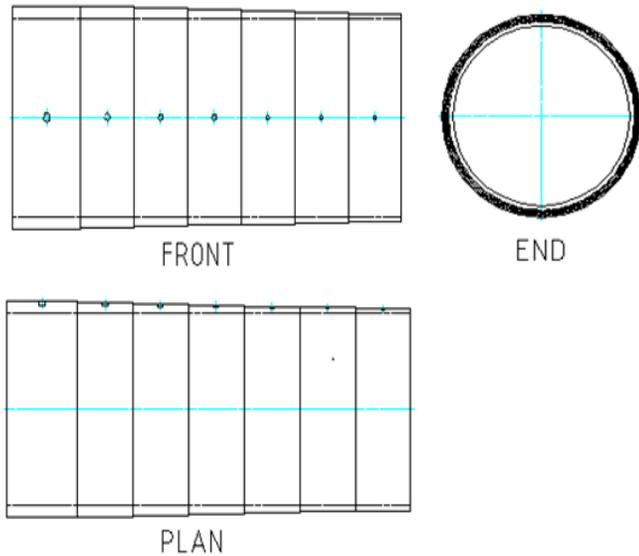
Figure 5. Orthographic views of the exteriorly machined pipe.

EXTERIOR MACHINED PIPE			LENGTH OF PIPE = 400.00 mm			
Step	Step Block Thickness (mm)	Pits (Drill) Diameter (mm)	Pits Depth (mm)	Outer Diameter (mm)	Inner Diameter (mm)	Step Block Length (mm)
Step 1	4.00	3.00	0.50	164.60	156.60	55.00
Step 2	5.05	3.20	0.80	166.70	156.60	55.00
Step 3	6.25	4.00	1.20	169.10	156.60	55.00
Step 4	7.30	4.50	1.60	171.20	156.60	55.00
Step 5	8.40	5.00	2.00	173.40	156.60	55.00
Step 6	9.45	6.00	2.50	175.50	156.60	55.00
Step 7	10.60	7.00	3.00	177.80	156.60	70.00

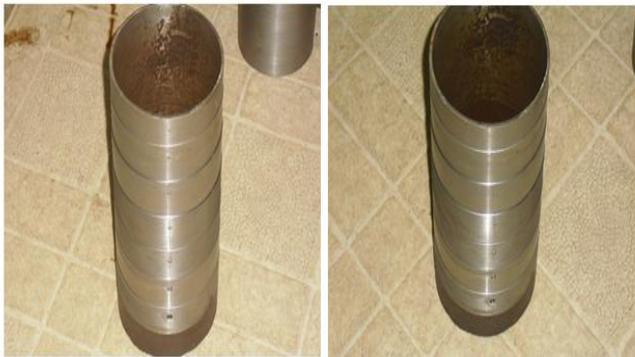
Figure 6. Exteriorly machined pipe (test pipes).

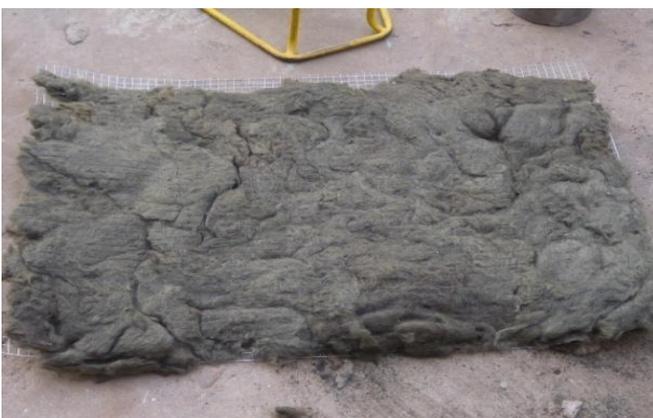
Figure 7. Fibre wool insulating material

The material used to simulate the deposit attack in the experiment is concrete with uniform thickness of 40 mm within the internal diameter of the pipe and a fibre wool insulator of 30.00 mm thickness was used to insulate the pipe.

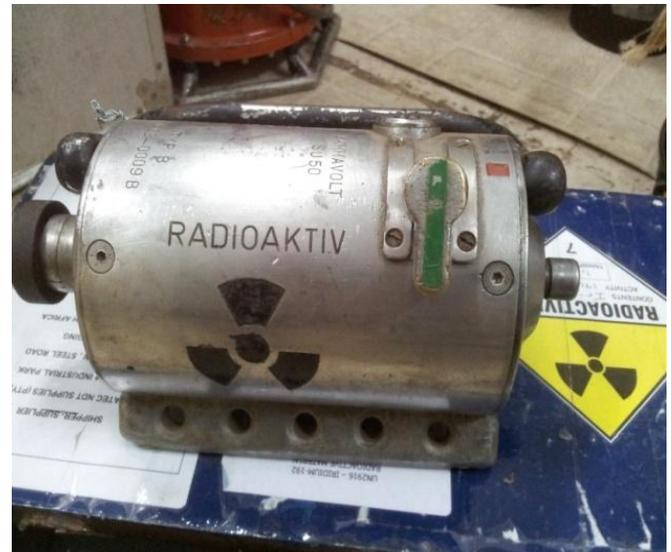
Figure 8. Gamma Ray Source (Ir-192)

Gamma-Ray Source (GAMMAVOLT – SU50)

Type B(U) D/DB-0009B

Weight 16kg/ U(depleted) 12.1kg

Activity 3700 GBq (100 Ci), Ir-192

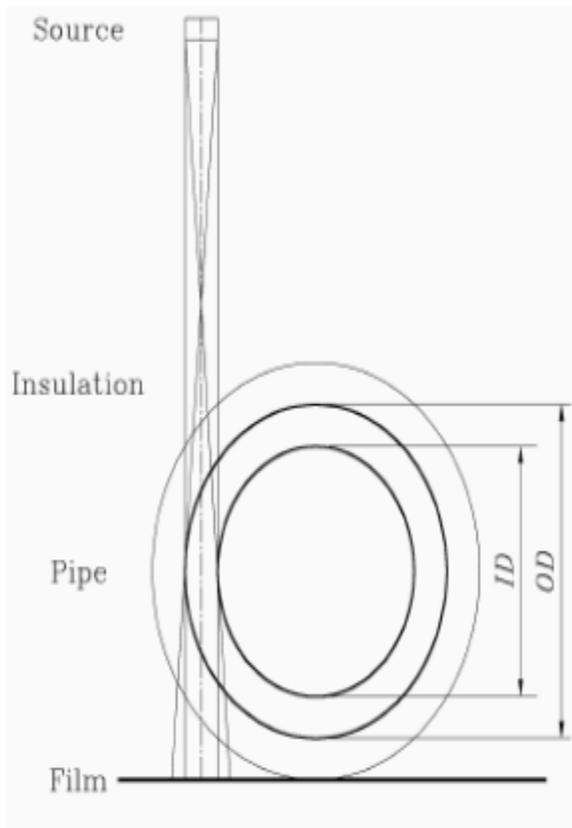
Figure 9. Test arrangement for Tangential Radiography [3].

The tangential radiography set-up for the pipe is presented in the figure 9. The source was positioned tangential to the wall of the pipe, because of the large nature of the diameter. The source had to be collimated to prevent backscatter and also to focus the beam to the target area of interest, its activity at the time of conducting the test was 45 curies (Ci). The source-film-distance (SFD) 1485.00 mm was maintained both for insulated and non-insulated pipe but with exposure times of 45, 50, 55, 80 and 90 seconds. The exposure angle between the source, the tangential position and the central axis of the pipe was 87 degrees and this was determined using equation 7. The radiographic film was plated around the circumference of the pipe. The remaining wall thickness and the depths of the pits were projected on the film by orienting both the pipe and source. The method was able to measure wall thickness on two sides of the pipe in the same exposure. The radiation source was placed above the pipe being radiographed tangentially rather than at centre of the pipe. Shading of the tangential radiograph between the two sides allows observation of local corrosion, erosion, deposits and pitting. The tangential paths of radiation within the pipe walls projected the edge location, and the pipe thickness to be evaluated. Thinning on the bottom of the pipe, process material deposit in the bottom of the pipe, and other defects

related to corrosion and deposits were made possible to be viewed [2].

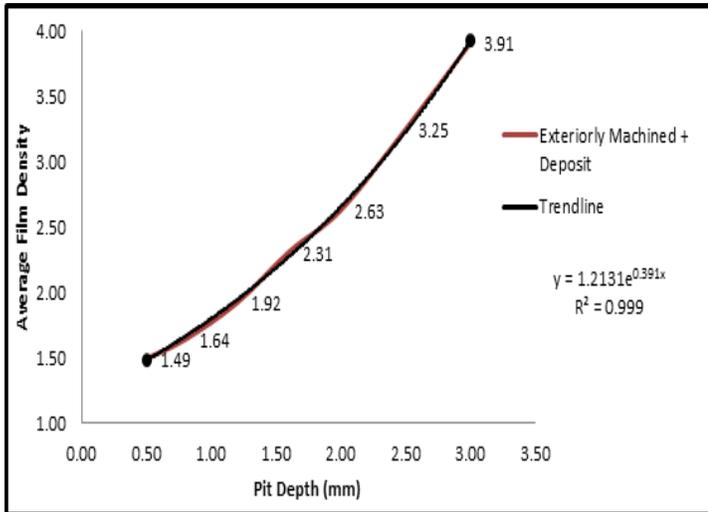
Figure11. Exteriously Machined Pipe and Deposit Using the Tangential Radiographic Technique.

The results of the experiment for the exterior composite pipe geometry, the interiorly machined pipe including insulation are shown in table 3 and 4 respectively. Table 5 shows the magnification factor and correction of the exterior composite pipe geometry. Figure 11, 12 and 13 are graphs of average film density and pit depth of exteriorly machined pipe and deposit, the exterior composite pipe geometry and the interiorly machined pipe and insulation respectively. Density variation against pit depth at different exposure conditions and comparison between actual and measured pit depths are shown in figure 14 and 15 respectively.

Insulation on pipe is most often used to preserve the thermodynamic properties of the flowing media and also protect the pipe surface from environmental attack. The presence of insulating material on the pipe makes other non-destructive methods impossible to access the internal profile of the pipe. From the experimental results, the insulating material insignificantly interfered with the radiographic exercise; this is exemplified in the closeness of the average density values in figure 11 and 12. From the exponential equations of both graphs ($y = 1.2131e^{0.391x}$, $y = 1.2218e^{0.390x}$), the attenuation coefficient of both the insulated and non-insulated pipe was near to zero difference. This is indicative of the fact that the insulating material had negligible attenuation coefficient on the incident radiation. Variation with the build-up factor (1.2131 and 1.2218) is as results of the differences in thickness of the material. The plot in figure 14 depicts a characteristic nature between density and the degree of penetration of pit in the pipe. The deeper the depth of the pit the more gamma radiation is transmitted leading to higher radiographic

density. It was also evident that, the more exposure time, the higher the density values, therefore it is imperative the exposure time be carefully managed in order not to over or under expose the test piece. This might generate pseudo radiographic density values which will give untrue representation of the test piece (pipe). The degree of the exposure angle greatly determines the time to expose the pipe that is the tangential area of pipe required much more exposure time compared with film density - thickness relation method. The three different exposure conditions depicted how the radiographic film density varied with thickness of material. This confirmed the linear relationship that attenuation or absorption coefficient had with thickness. From the measured pit depth on the radiographic film, the estimated pit readings were close to the actual pit diameter on the pipe with magnification factor ranging between 1.08 – 1.09.). The over estimation of pit depth by the tangential radiographic technique was due to the magnification factor. This can be used to predict accurately the actual pit depth if the magnification factor and correction are applied to the estimated pit depth read on the radiograph. In a complex pipe system it is particularly important to obtain information regarding the ability of a corroded pipe to accommodate the axial stress. Further deterioration or internal metal loss may result in the pipe wall being unable to carry these axial loads. With reference to figure 13, the extent of pit propagation (pit depth) can be determined from the reference curve whenever the radiographic density is known. Knowledge of the degree pit propagation will aid in the establishment of the design safety-factor load to be sustained by the pipe.

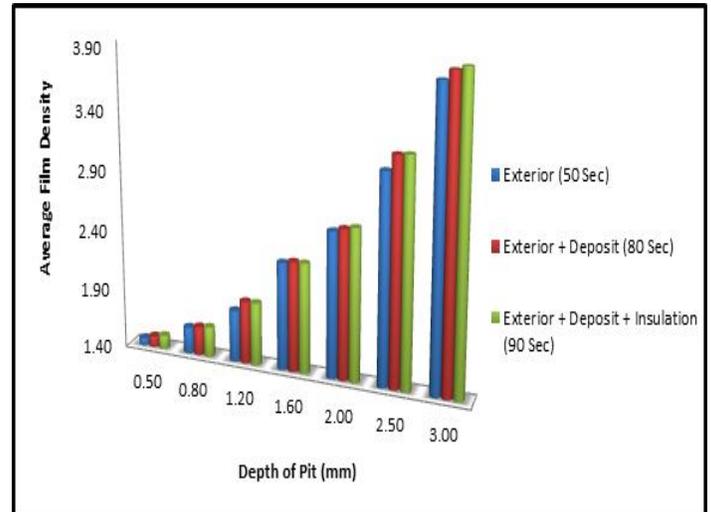
Figure14. Density variation versus Pit depth at different Exposure Conditions by Tangential Radiographic Technique.

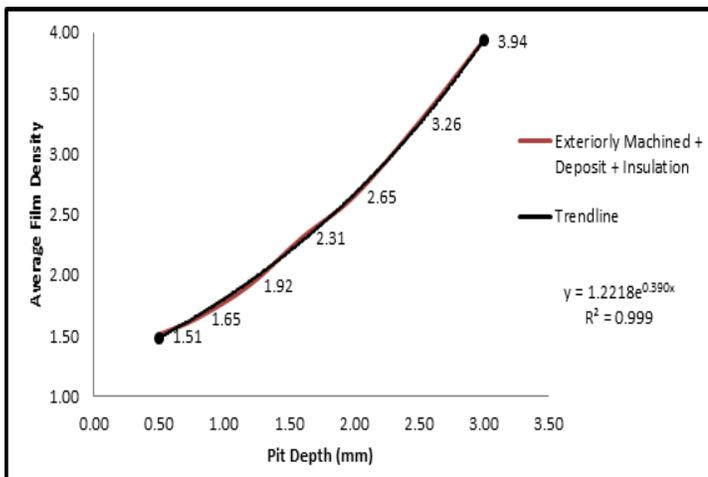
Figure12. Exteriously Machined Pipe, Deposit and Insulation Using the Tangential Radiographic Technique.

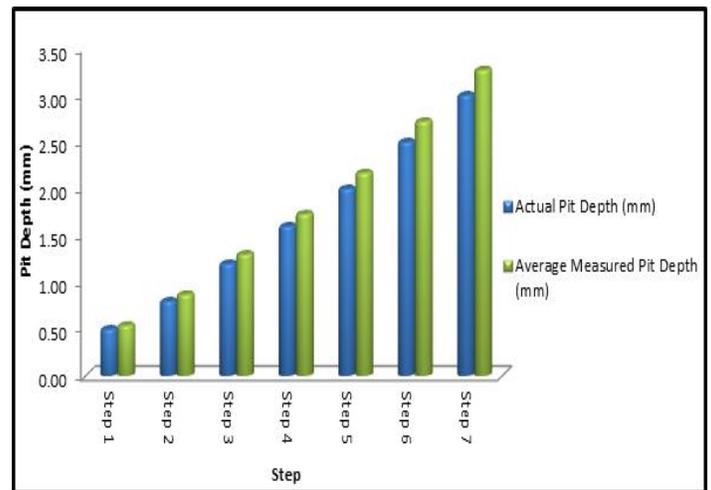
Figure15. Comparison between Actual and Measured Pit Depth by Tangential Radiographic Technique.

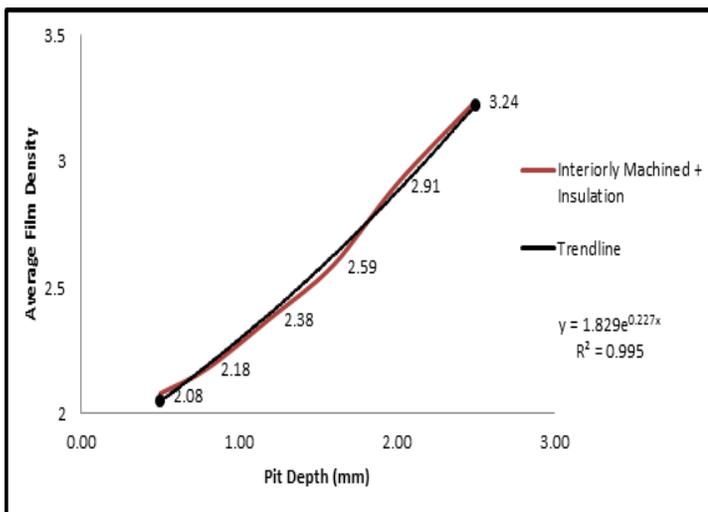
Figure13. Interiorly Machined Pipe and Insulation Using Tangential Radiographic Technique.
